# Manhole Inspection Summary

Manhole # S15UU\_004MH

**Location** Address: **3101 TOWANDA AVE**

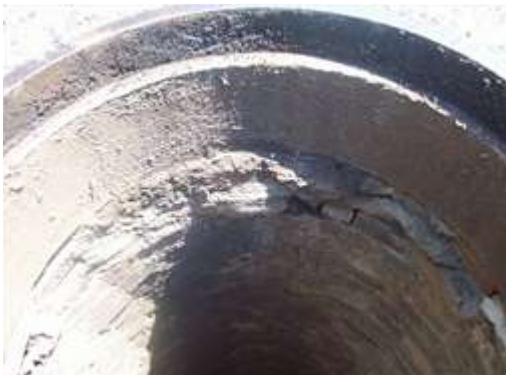
Defect 1

Condition: ☐ Sound ☒ **Cracked** ☐ Root Intrusion ☐ Loose Brick ☐ Deteriorated

CRACKED FRAME ADJUSTMENT

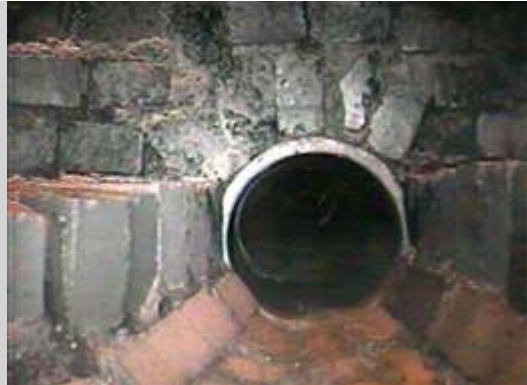
12 O'Clock Outflow

8 in. Circular Gravity Sewer  
Pipe Out @ 12 O'Clock

Pipe Height: (in.) Direct  
Pipe Material: **Clay** ☐ Pipe Lined  
Invert Depth: **13.85** (ft.) Flow Characteristics: **Fast**  
Deposits: ☒ None ☐ Mud ☐ Gravy ☐ Debris ☐ Grease  
Silt Depth: (in.) Deposits Extent:  
Infiltration: **None** Pipe Seal Cond: **Sound**

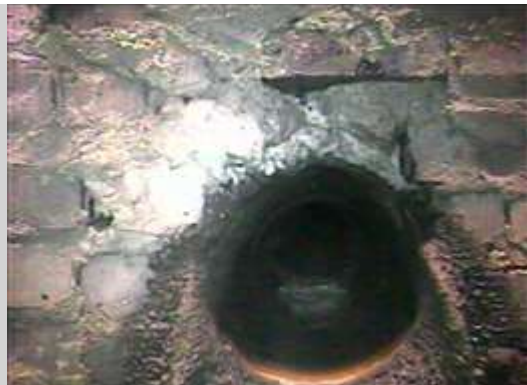
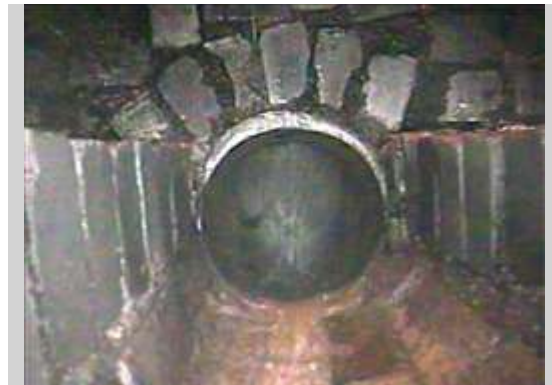
6 O'Clock Inflow

8 in. Circular Gravity Sewer  
Pipe In @ 6 O'Clock

Drop In @ 6 O'Clock

Pipe Height: (in.) Direct  
Pipe Material: **Clay** ☐ Pipe Lined  
Invert Depth: **7.65** (ft.) Flow Characteristics: **Fast**  
Deposits: ☒ None ☐ Mud ☐ Gravy ☐ Debris ☐ Grease  
Silt Depth: (in.) Deposits Extent:  
Infiltration: **None** Pipe Seal Cond: **Sound**

Drop: **Outside Direct**

Drop Condition: **Open**

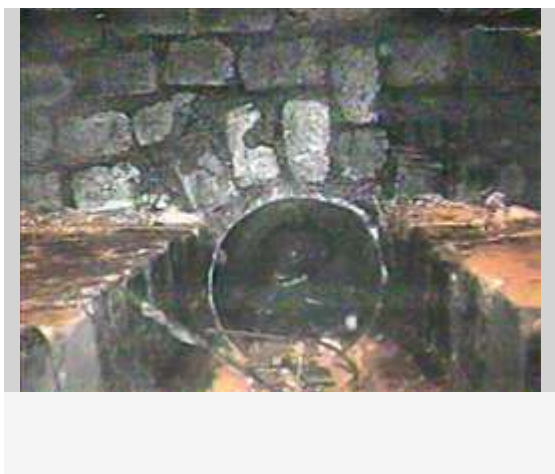
9 O'Clock Inflow

8 in. Circular Gravity Sewer  
Pipe In @ 9 O'Clock

Pipe Height: (in.) Direct  
Pipe Material: **Clay** ☐ Pipe Lined  
Invert Depth: **13.75** (ft.) Flow Characteristics: **Slow**  
Deposits: ☐ None ☒ **Mud** ☒ **Sludge** ☒ **Debris** ☐ Grease  
Silt Depth: **1** (in.) Deposits Extent: **Light**  
Infiltration: **None** Pipe Seal Cond: **Sound**

Connects To: **House connection / Service line**  
☐ Possible Illicit Connection
